Manhole Inspection Summary

Manhole # S11AA2016MH

Insp Date: **9/27/06 2:57 PM**

Location Address: **5714 GREENSPRING AVE**

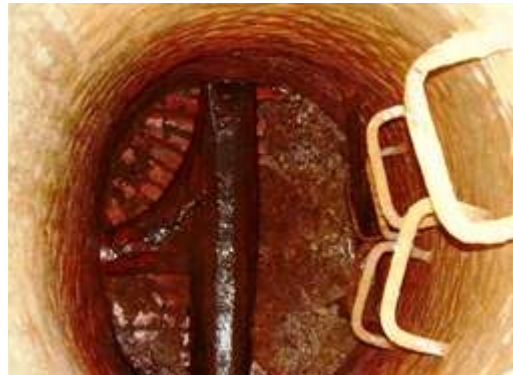
Top View

Evidence of surcharge - Bench debris.
Corroded steps.

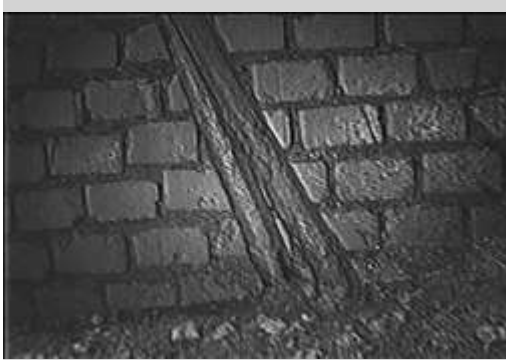
Defect

Bench debris. Barrel infiltration.

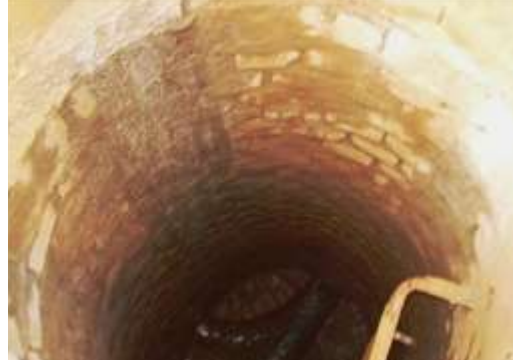
Defect

Frame leaks. Adjustment and Corbel
infiltration.

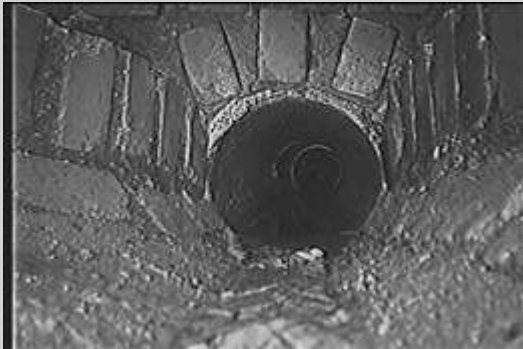
8 in. Circular Gravity Sewer Pipe Out @ 12 O'Clock

Infiltration: **Evidence** Pipe Seal Cond: **Unknown**

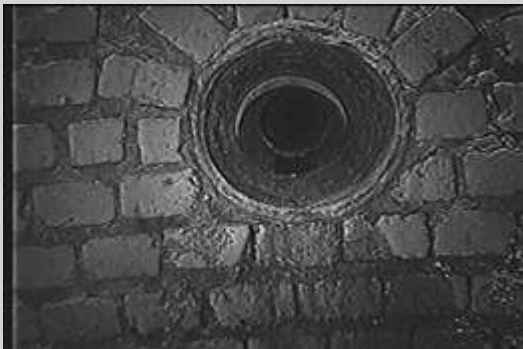
8 in. Circular Gravity Sewer Pipe In @ 6 O'Clock

Infiltration: **Evidence** Pipe Seal Cond: **Unknown**

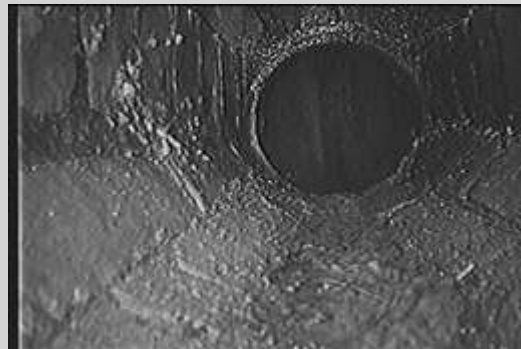
Drop In @ 6 O'Clock

Drop: **Outside** Rod and Bar

Drop Condition: **Open**

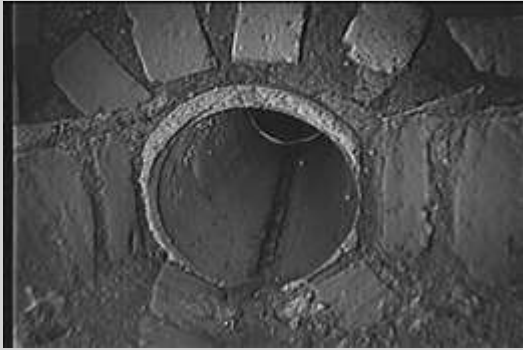
Pipe In @ 9 O'Clock

Infiltration: **Evidence**

Pipe Seal Cond: **Roots**
